# FORD FOUNDATION HISTORIC RENOVATION NEW YORK, N.Y.

Meticulous detail and new glazing for a landmark building.

# CASE STUDY

Architectural glass and metal for  
a 420,000-square-foot historic  
renovation of a 1967 headquarters

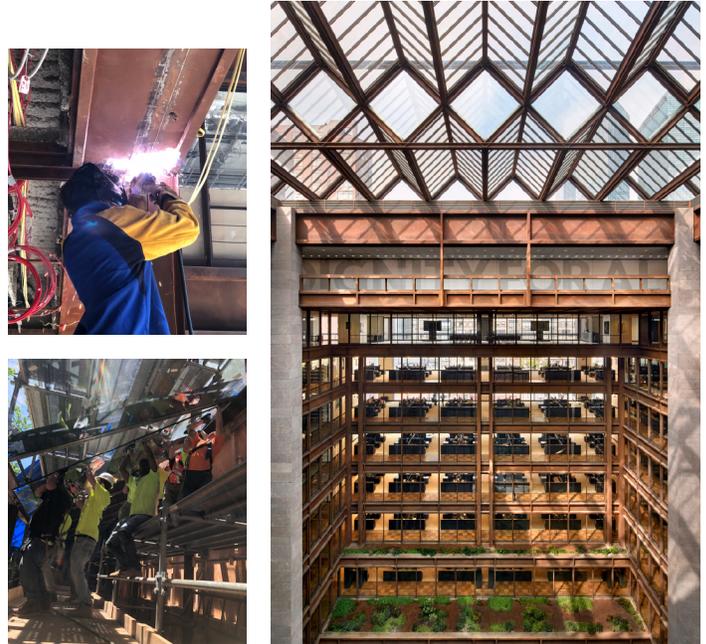
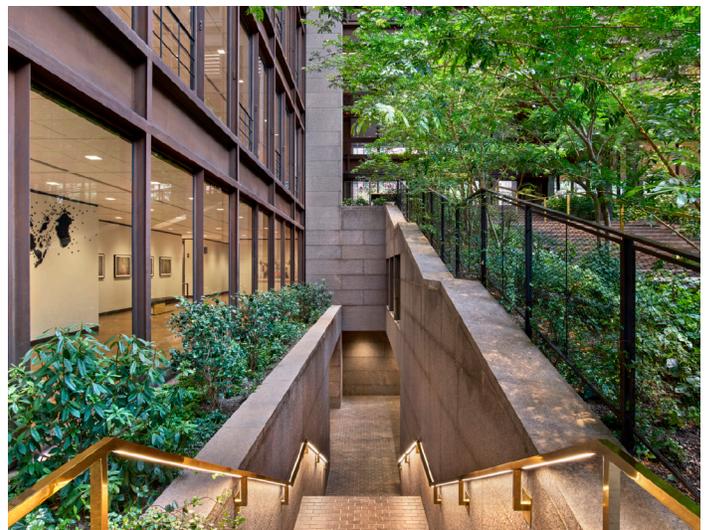
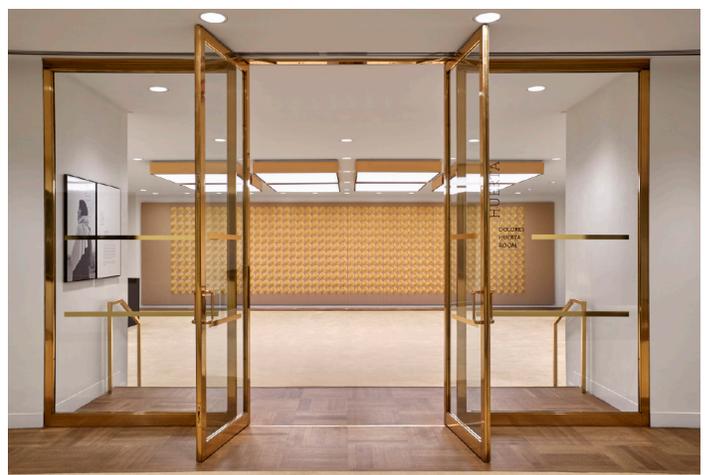
*Clockwise: interior atrium showing roof/skylight system; garden loggia with new purge windows and lighted brass handrails; interior brass doors; the Beletz Bros. team setting glass from below; welding Corten*

One of the building’s character-defining features is its sawtooth glass roof and skylight system, which spans the full footprint of the building above a full-height atrium. Beletz Bros. performed a complete restoration including removal, cleaning, and replacement of all gaskets, pressure plates, beauty caps, frames, and glass. LU252 glazier Andrew Mattie, who led the job, was fortunate to have original drawings for reference.

renovating the glass wall into a fully power-operated fire/smoke-purge window system. Each opening includes a subframe, window, and power operator finished to match the existing Corten steel. According to Beletz, the section was boarded up when the project began, to protect it from work taking place above. "When we first looked at the job, we couldn't see it," he explained. "But everything was rotted." A structural engineer prepared all new drawings and Beletz did the careful reconstruction to ensure the new work matches the original appearance.

The original building design featured dozens of brass doors in single and double sets. The renovation design preserved as many as possible. These were removed and brought to the Beletz Bros. shop where new hardware (either refurbished or new machined to match the original) was installed. Doors were stripped, polished, and re-lacquered, with minor welding as needed before being reinstalled. In situations where the old doors no longer met code, Beletz Bros. installed new custom center hung and balance doors that were fabricated to match existing framing. Hand artistry finishing techniques were used to replicate different shades of patina.
